Inspection Report

1 - Private - 100 Keenan Ct

100 Kennan Ct
Verona WI 53593

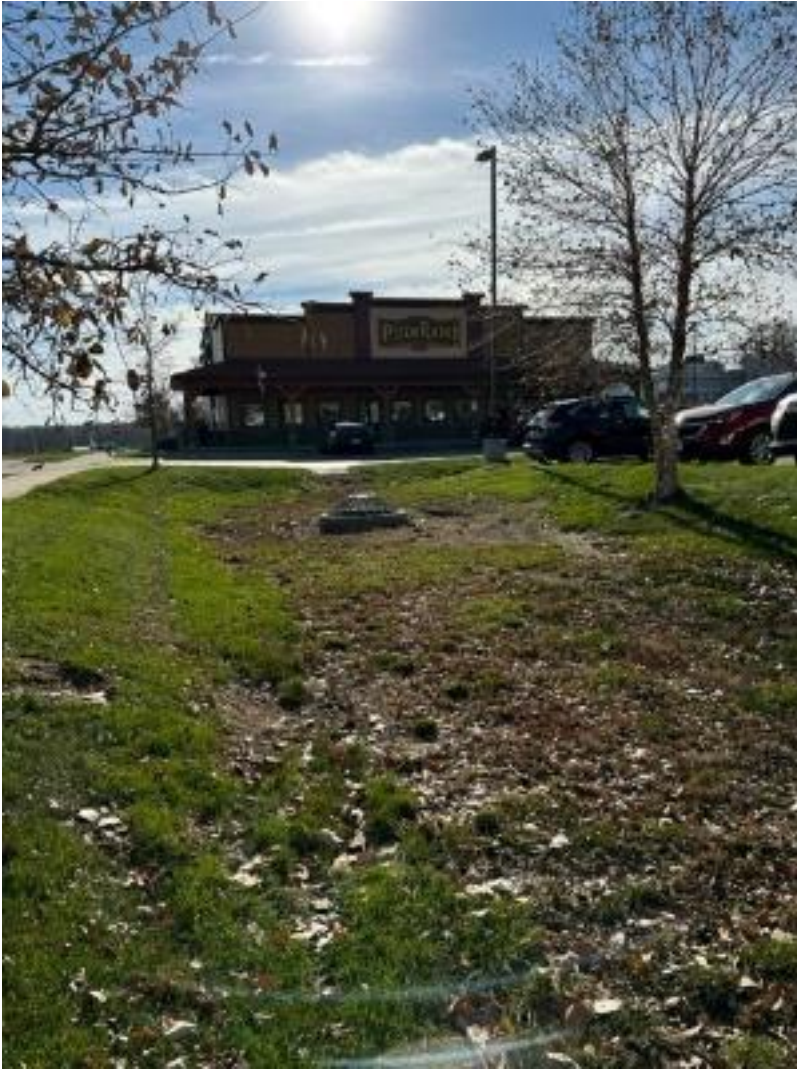
Name: Admin/ Site Conditions -- Photo Documentation of Site

Condition: Correct

Description: Photo showing current site conditions.

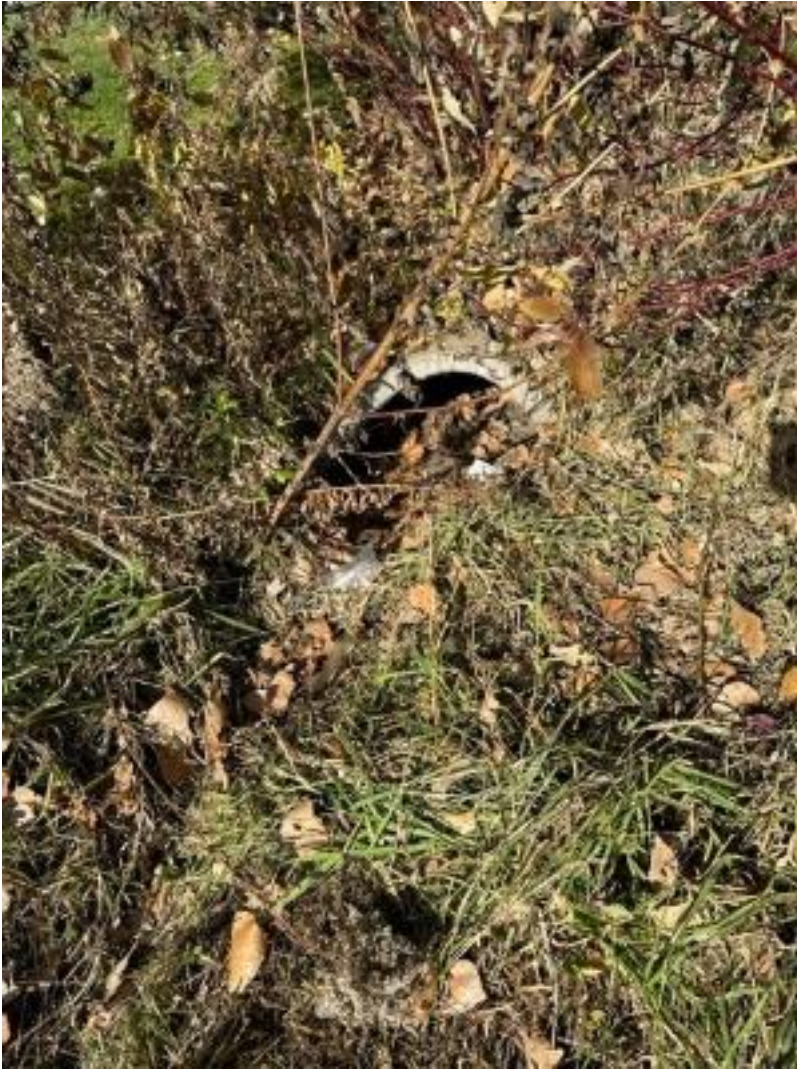
Name: Control Structure -- Pipe Condition

Condition: Correct

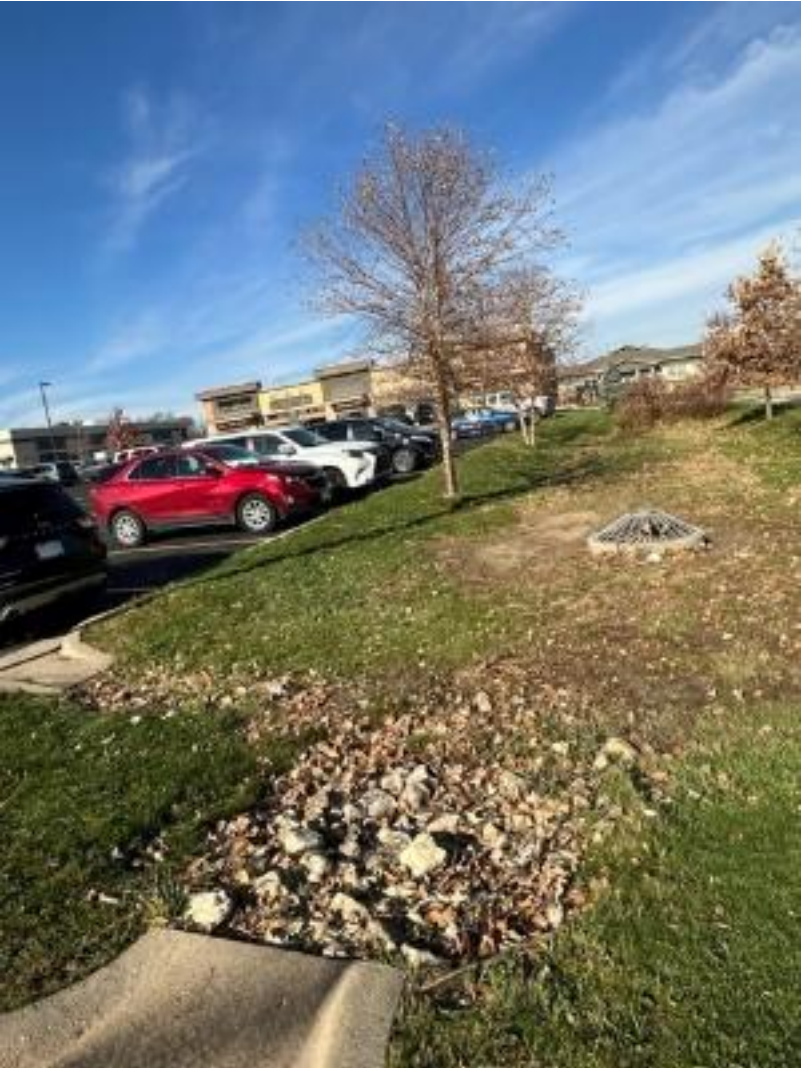
Name: Bioinfiltration -- Eroded or Muddy Channel

Condition: Correct

Comment: add rip rap to concrete ramp inlets to prevent erosion and gullies forming

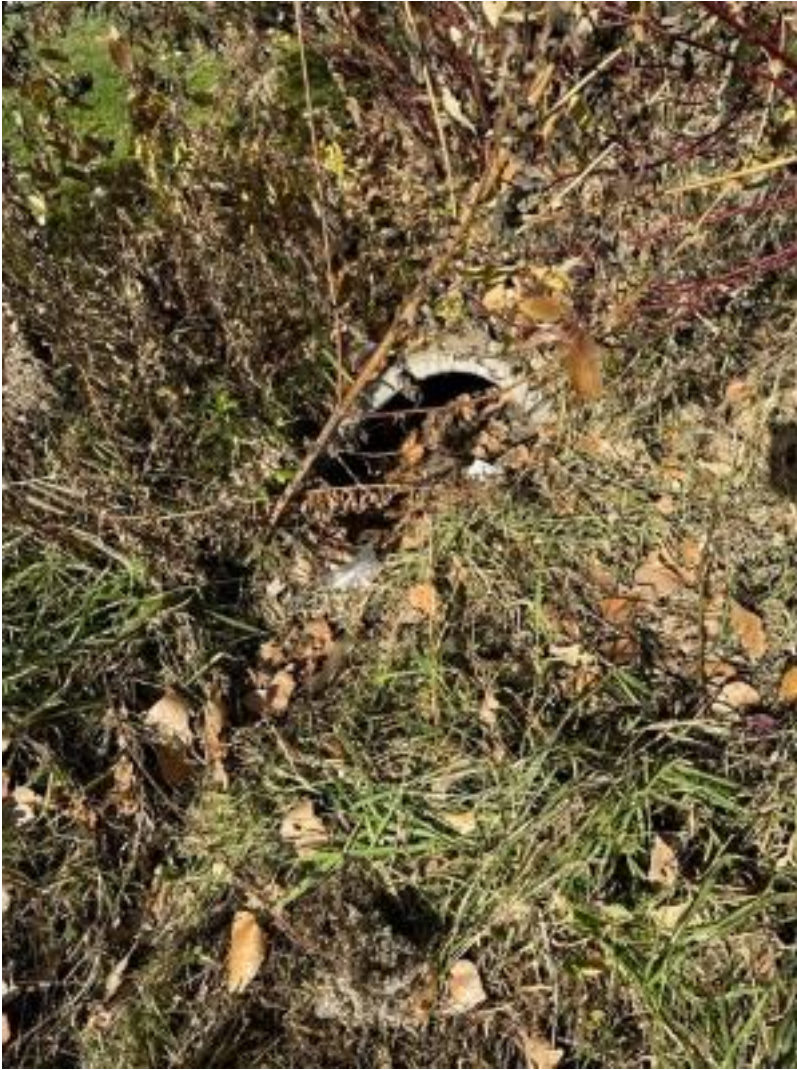
Name: Admin/ Site Conditions -- Trash/ Debris

Condition: Routine Maintenance

Comment: clean up trash and vegetation debris around inlet pipe and in basin

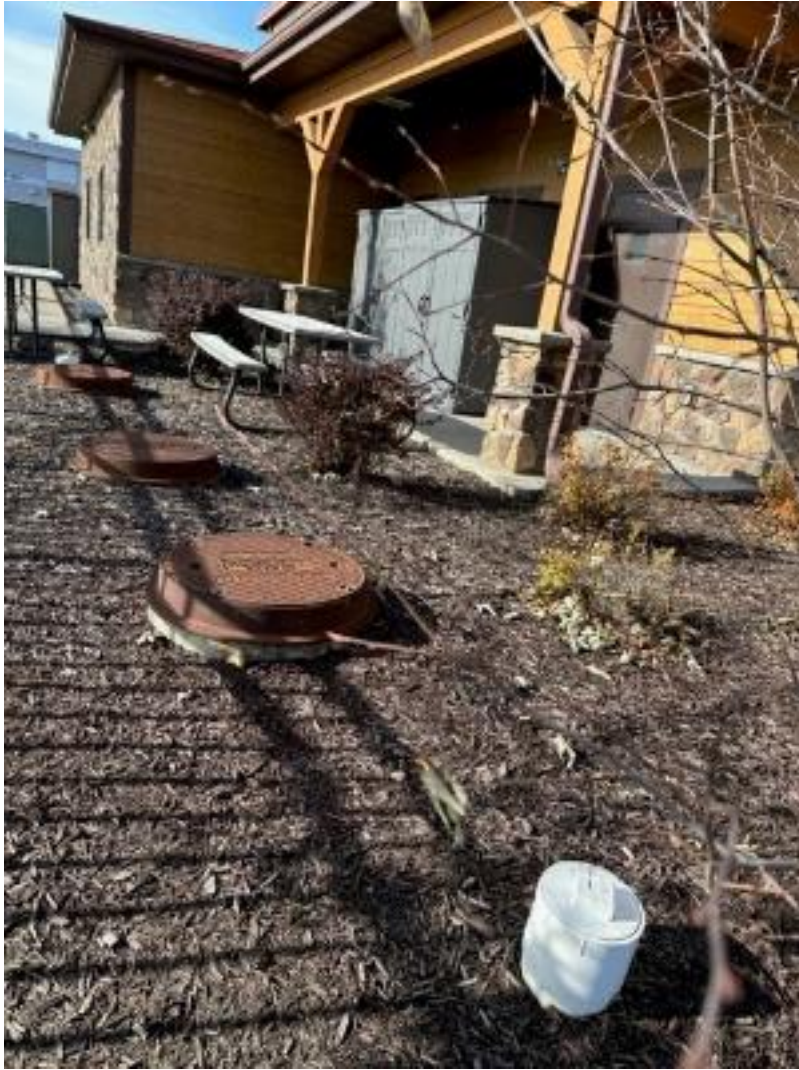
Name: Admin/ Site Conditions -- Miscellaneous

Comment: back patio cleaners and manholes in good condition

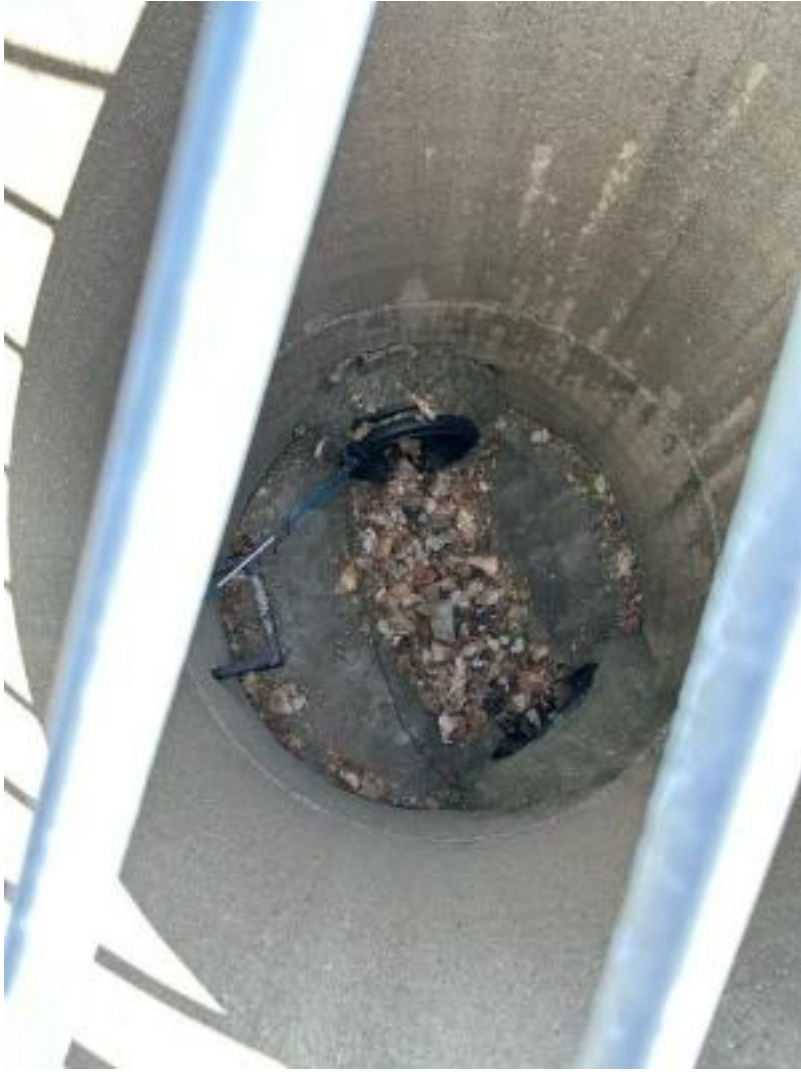
Name: Bioinfiltration -- Sediment Accumulation

Comment: little to no leaf debris and sediment accumulation in outlet structure
